# SpaceWire CODEC Update

Steve Parkes, Chris McClements,  
Martin Dunstan  
University of Dundee

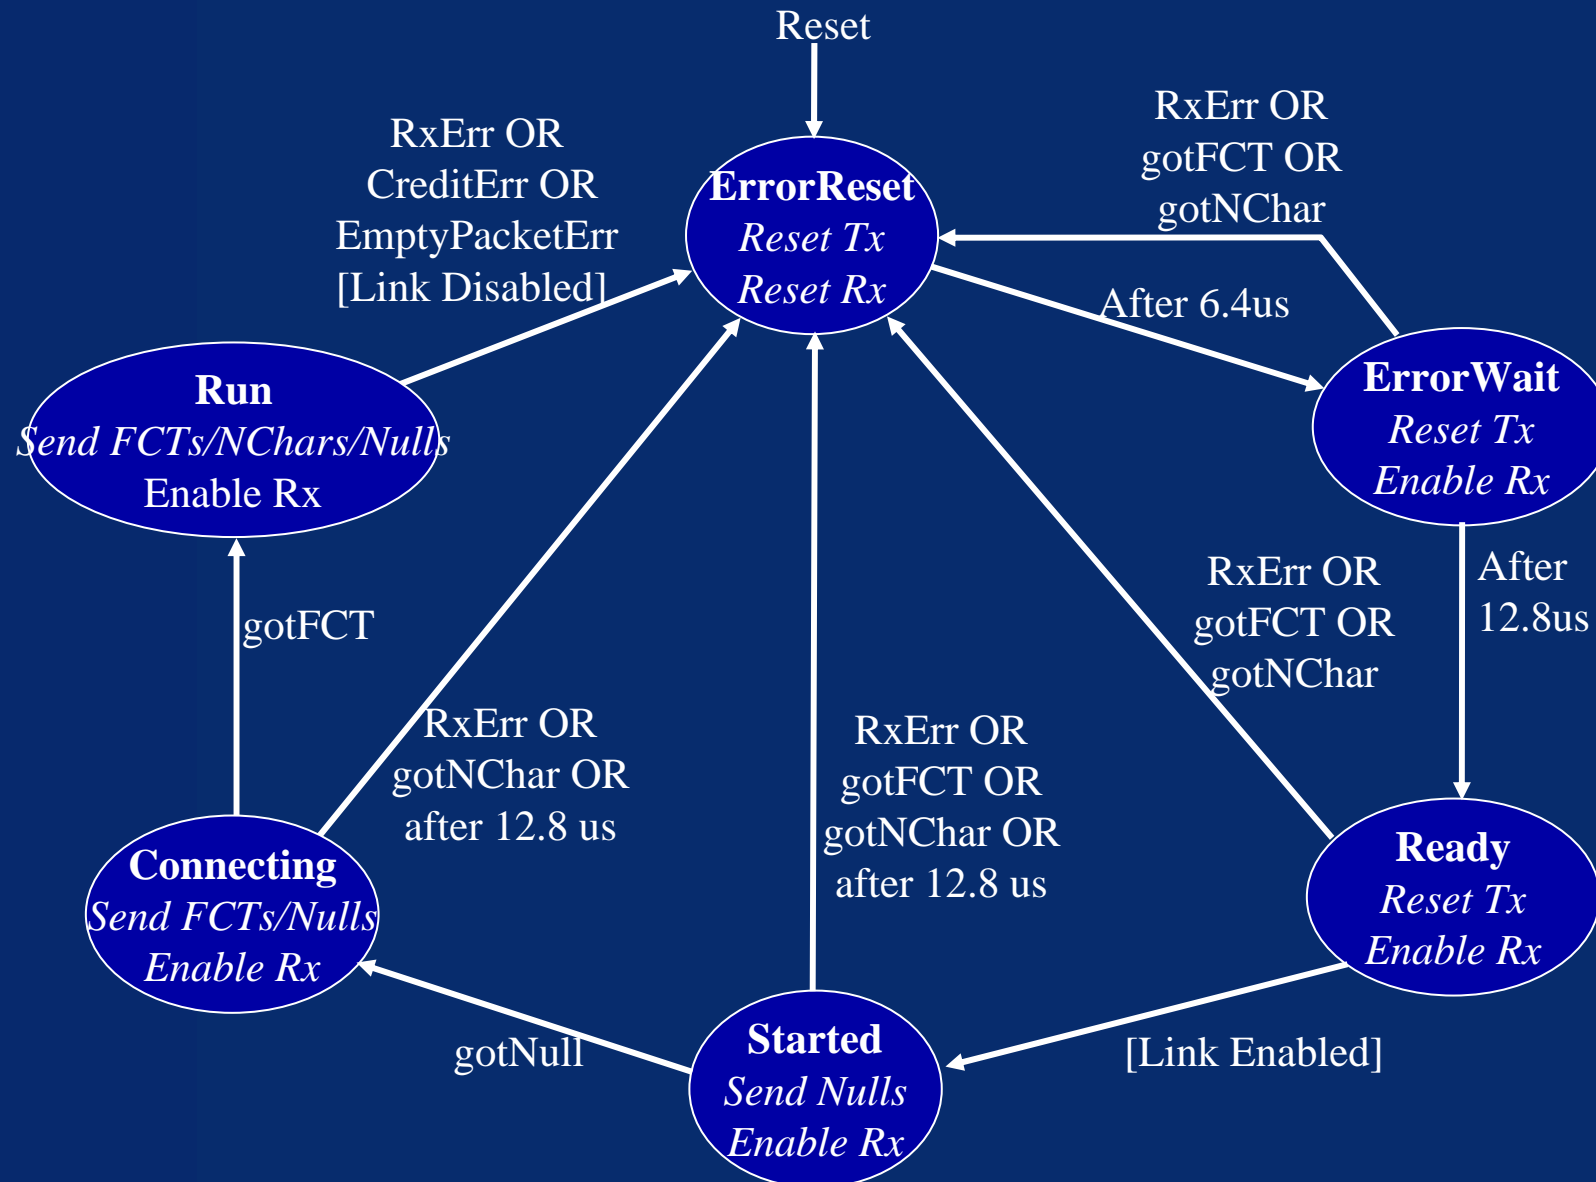
# SpaceWire Link State Machine

- Link recovery timing on multiple cycles through Link Reset state
- First time round timing is correct
- Problem detected by SpaceWire Conformance Tester

- Transition timer always reset on entry to ErrorReset state
